The ESE and CVM Lightning Air Terminals: A 25 Year Photographic Record of Chronic Failures

Z. A. Hartono and I. Robiah

APL 2017

The 10th Asia Pacific International Conference on Lightning
May 16 - 19, 2017, Krabi Resort, Krabi, Thailand

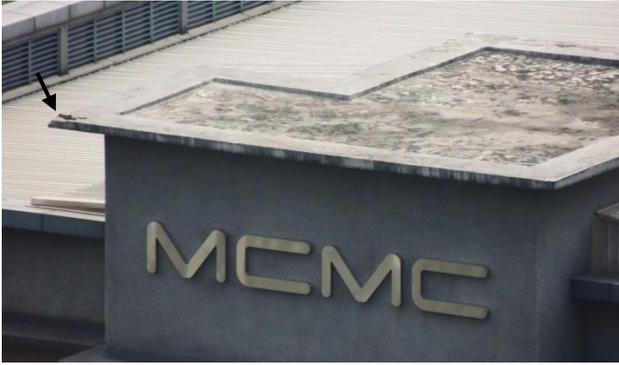
Fig. 2.1. A small bypass located at the corner of the roof of a public building. This is the most common shape of bypasses seen in Malaysia.

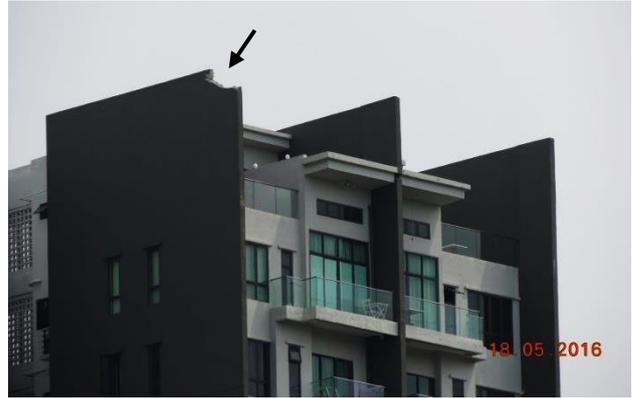
Fig. 2.5. A much larger bypass on top of a firewall. The same bypass shown in fig. 2.4 had been repaired earlier.

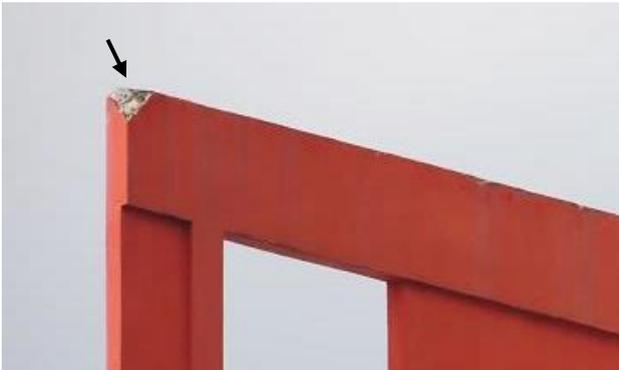
Fig. 2.2. A small bypass on top of a facade with the lightning impact point at the wall end.

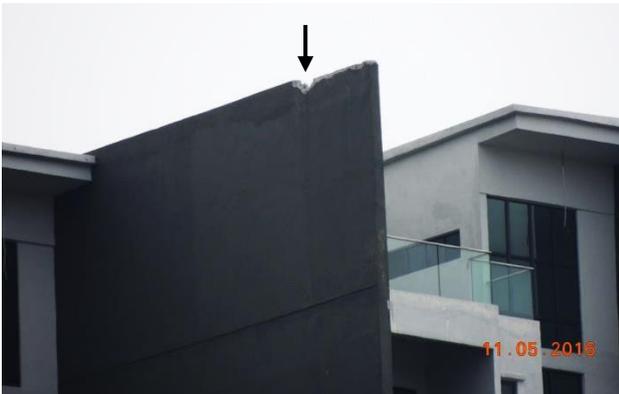
Fig. 2.3. A small bypass on top of a firewall with the lightning impact point located away from the wall end.

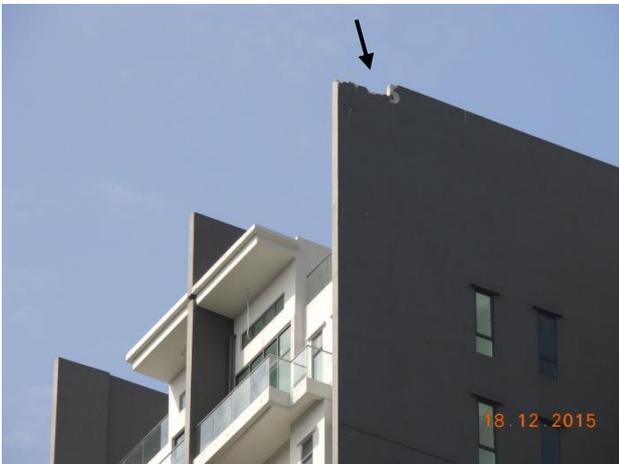
Fig. 2.4. A larger bypass on top of a firewall.

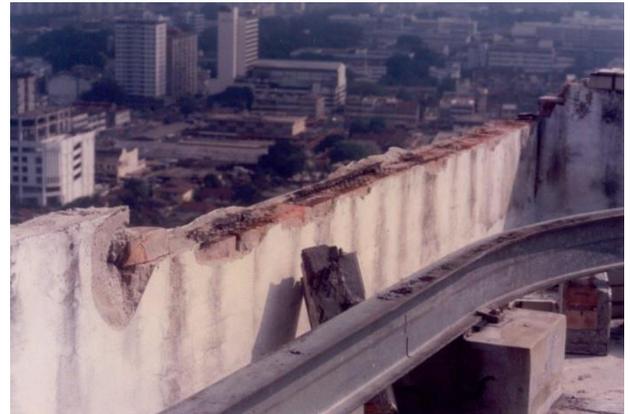
Fig. 2.6. A very large bypass on the parapet wall, photographed in 1991. The building had just been installed with a CVM air terminal.

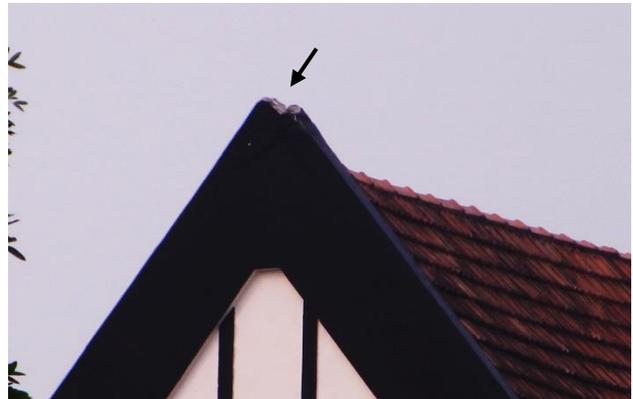
Fig. 2.7. A bypass on top of a pointed facade.

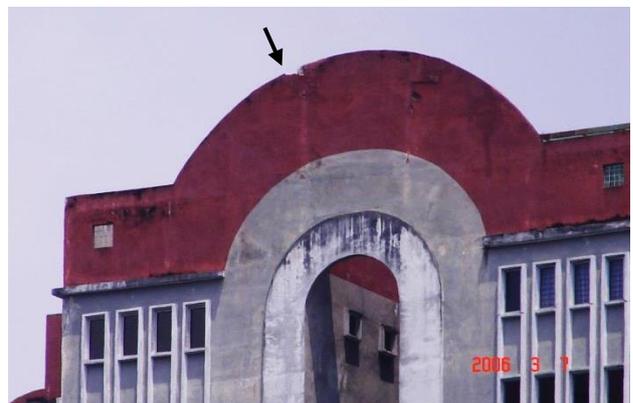
Fig. 2.8. A bypass on top of a curved facade.

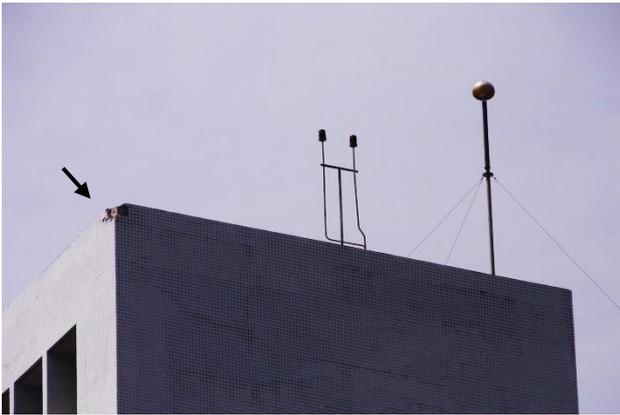
Fig. 3.1. A bypass near a CVM air terminal. The building has been struck about six times before this bypass occurrence.

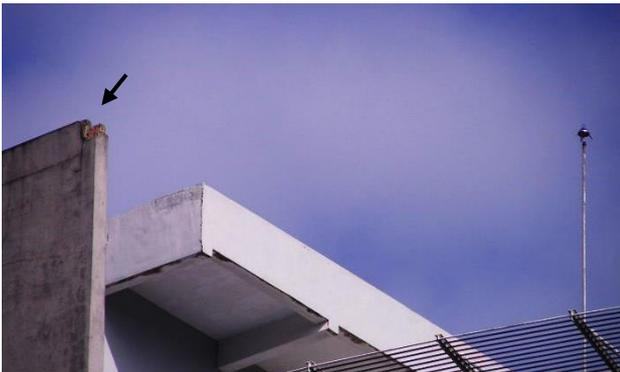
Fig. 3.2. A bypass on one end of a façade near an ESE air terminal. A similar bypass also occurred at the opposite end of the same building.

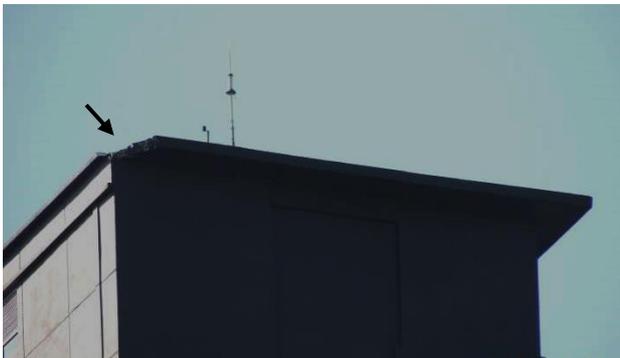
Fig. 3.3. A bypass on one corner of the roof of the elevator motor room near an ESE air terminal. Another bypass had occurred earlier at one of the distant corners of the same building.

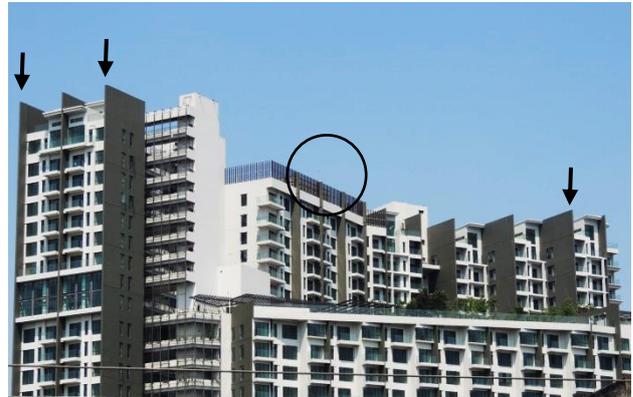
struck more than once per year. For example, the Univ360 apartment in Kuala Lumpur was struck at least six times over a period of two years resulting in three major bypasses.

Fig. 3.4. The Univ360 apartment was struck at least six times within a period of two years. The arrows indicate the locations of the major bypasses. See also figs 2.3, 2.4 and 2.5.

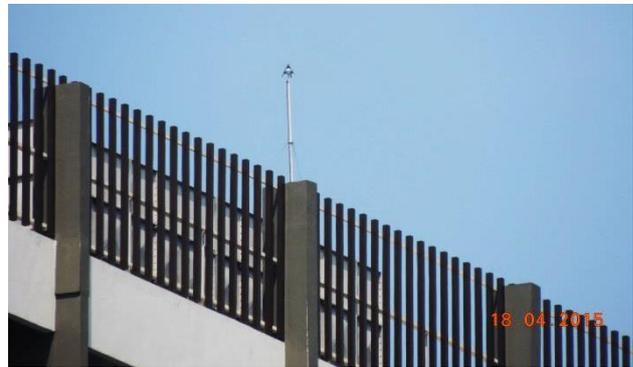
Fig. 3.5. The ESE air terminal installed on the Univ360 apartment and located at the center of the roof (circle in fig. 3.4).

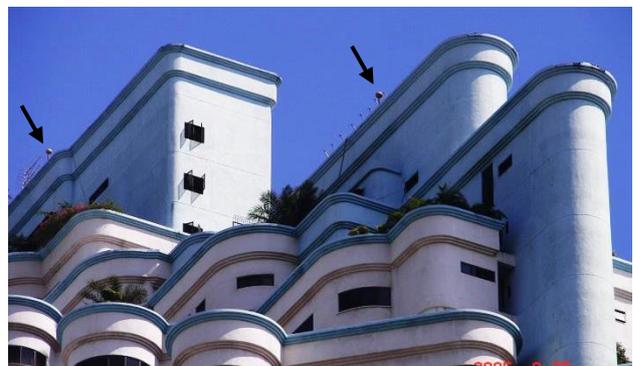
Fig. 4.1. A 100m high apartment building with multi-level roofs installed with two CVM air terminals (arrowed).

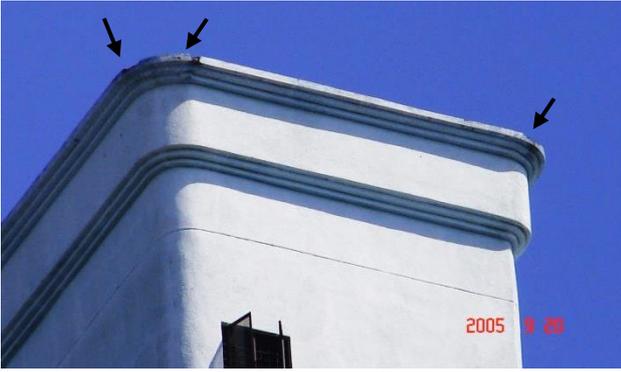
Fig. 4.2. Although located between two CVM air terminals, several bypasses were observed on this section of the upper level roof.

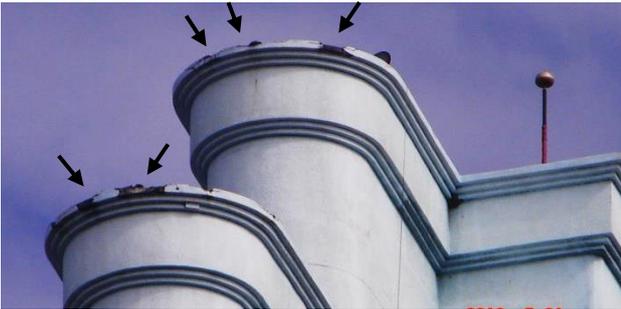
Fig. 4.3. Multiple bypasses were observed on the lower level parapet walls located near the CVM air terminal.

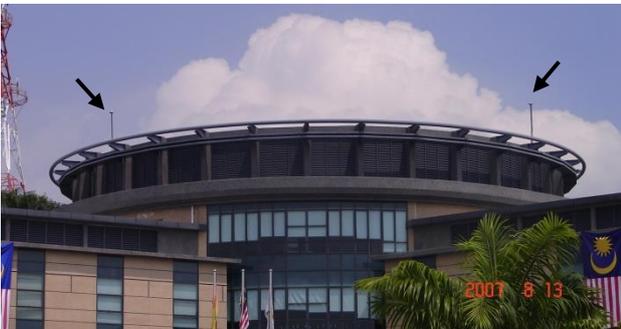
Fig. 4.4. Two second generation CVM air terminals (arrowed) installed on a low-rise public building.

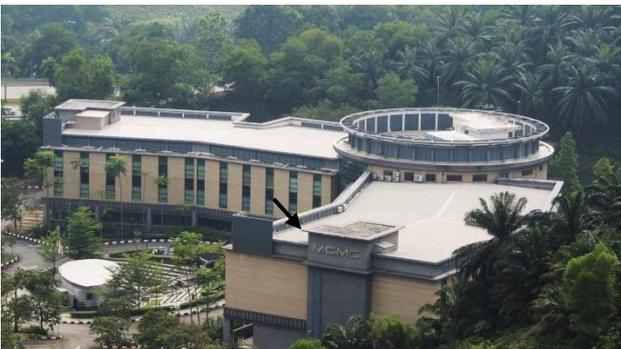
Fig. 4.5. A bypass was observed on the corner of the roof (arrowed). See fig. 2.1 for a close-up picture of the bypass.

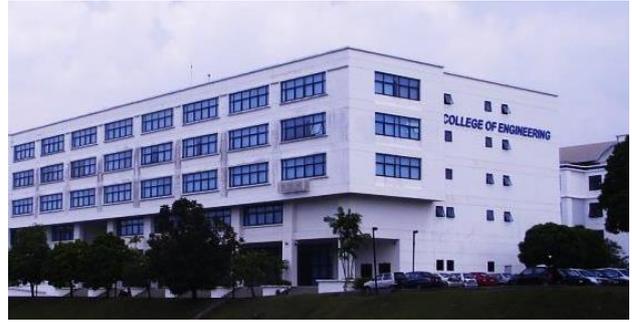
Fig. 4.6. A low-rise college building installed with one ESE and one CVM air terminals.

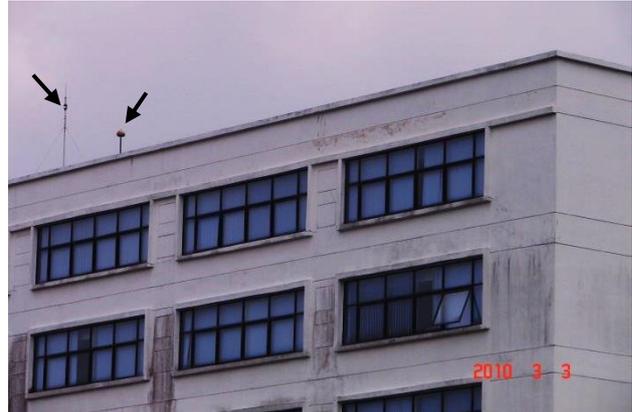
Fig. 4.7. The same building installed with two ESE/CVM air terminals (arrowed) and photographed without a bypass in 2010.

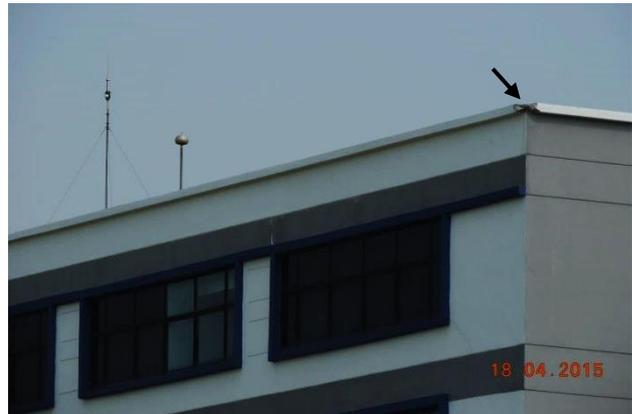
Fig. 4.8. The same building observed with a bypass (arrowed) in 2015.

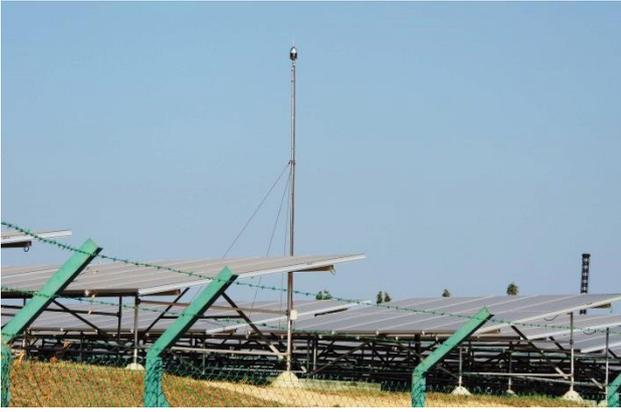
For example, in a reported lightning incident at a solar farm, several solar panels mounted about 1.5m above ground were struck by lightning although they were located within the claimed protection zone of one of several ESE air terminals that were installed throughout the farm.

Fig. 5.1. One of several mast-mounted ESE air terminals installed at a photo-voltaic farm where a bypass had occurred.

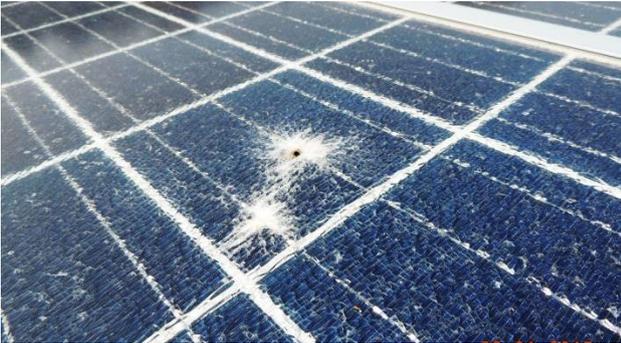
Fig. 5.2. Two of the bypasses on the center portion of a solar panel that was struck by lightning.

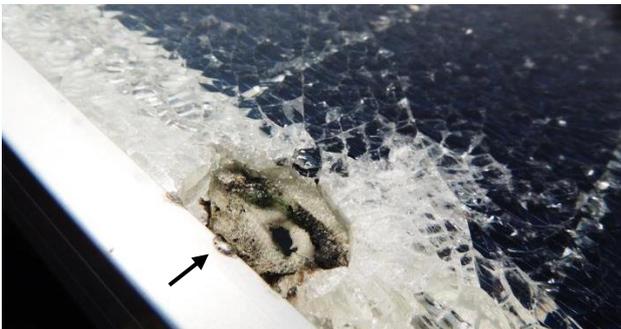
Fig. 5.3. One of the bypasses located at the edge of the solar panel. The blob of melted metal (arrowed) on the aluminum frame suggests that it was caused by a very high temperature event, such as a lightning stroke.

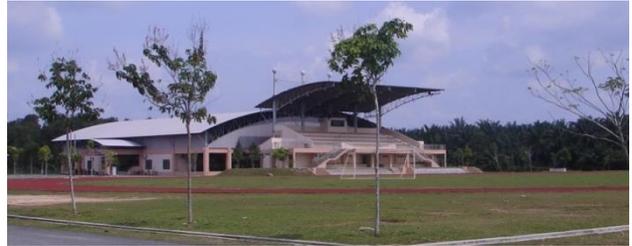
In 2012, a university student was struck and killed by lightning on a football field in front of a stadium grandstand. The metallic roof of the grandstand needed no protection against lightning but it had been installed with a pole-mounted ESE air terminal whose claimed protection zone covered the entire football field adjacent to the grandstand.

Fig. 5.4. The Malacca university stadium grandstand and field where the student was struck and killed by lightning.

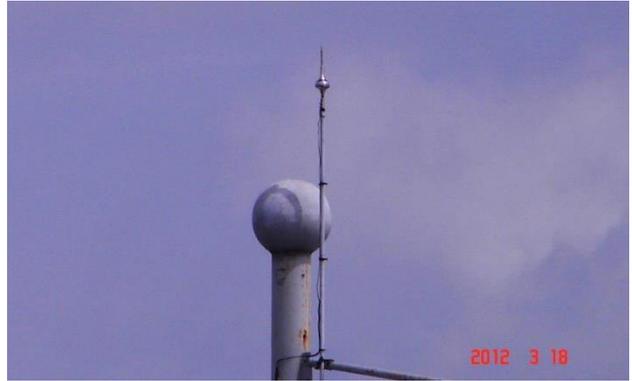
Fig. 5.5. The ESE air terminal mounted on one of the grandstand's metallic pillars.
