# Case Study of Lightning Damage to Wind Turbine Blade

by Richard Kithil, Founder & CEO  
National Lightning Safety Institute (NLSI) [www.lightningsafety.com](http://www.lightningsafety.com)  
June 2008

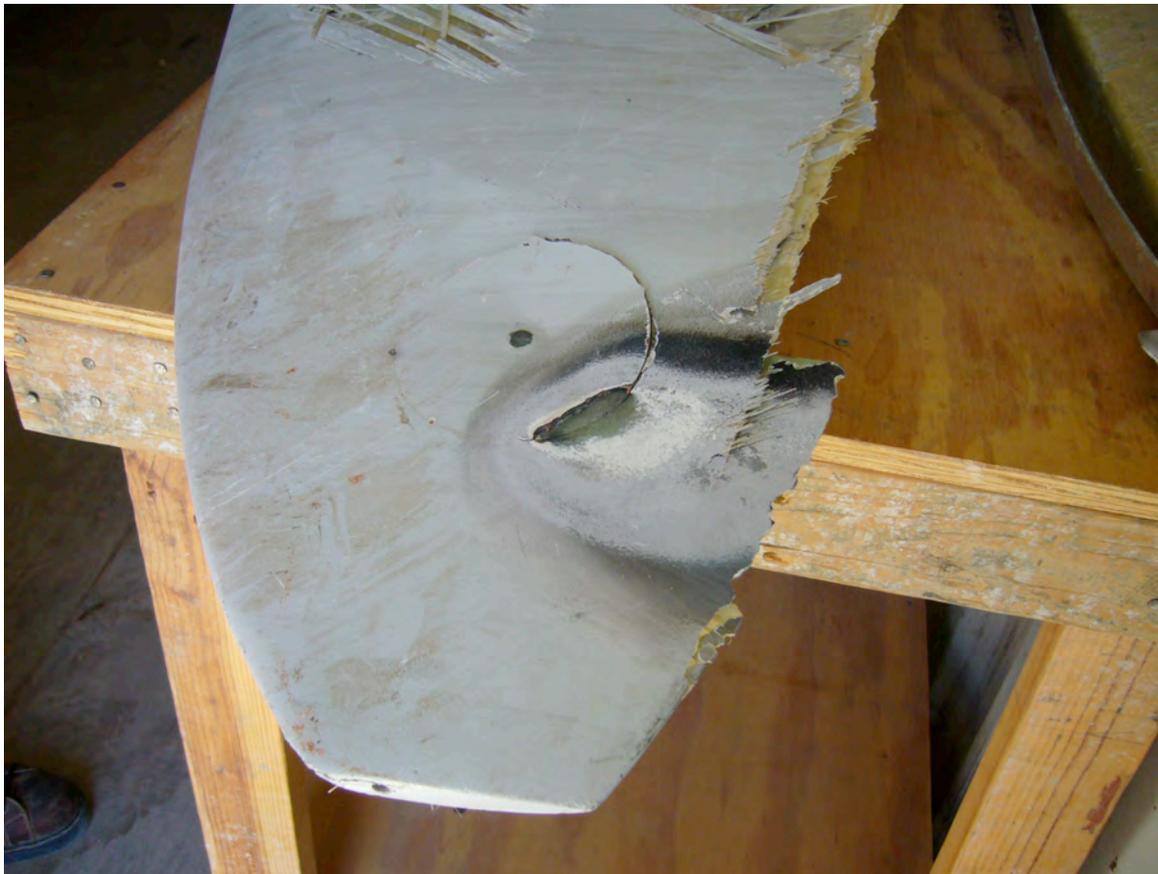
**Figure 1: Characteristic lightning signature to blade tip**

Lightning to Blade No. 4608 at Turbine No. 155 was the proximate cause of its subsequent failure. The National Lightning Detection Network at 08:30.36 on March 6, 2008 reported a 10kA strike in close proximity to the location of this turbine. Subsequent events are described. Our conclusions are based upon May 7-8, 2008 site observations, known lightning behavior, code references and studies by others.

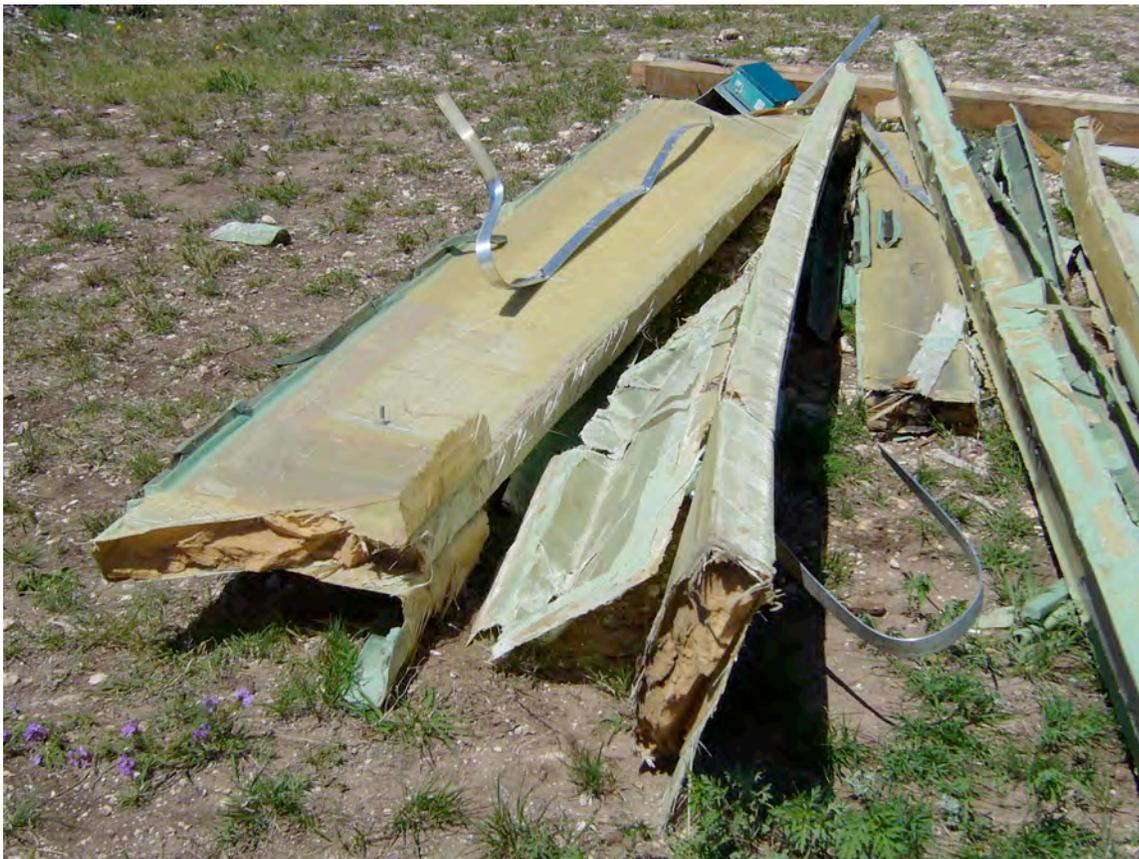
3.2 Lightning protection consists of several exterior copper “receptor” air termination discs, which are fastened to interior aluminum conductors running the length of the blade. Conductors are fastened to the blade and to one another with steel bolts. Near the blade root a portion of the conductor is imbedded into the fibreglas. The conductor transitions from the blade root area via bonding to the hub and thence to a ground reference.

**Figure 2: Damaged blade showing internal spars and lightning conductors**

- 4.1.1 Section 4.5 - Aluminum is acceptable in place of copper as a conductor.
- 4.1.2 Section 4.5.3 - “An aluminum conductor shall not be... installed in a location subject to excessive moisture.” The presence of moisture promotes corrosion on aluminum.
- 4.1.3 Section 4.10.2 - “No combination of materials shall be used that will form an electrolytic couple of such a nature that, in the presence of moisture, corrosion will be accelerated.” The aluminum conductors are secured to the blade using steel bolts. Steel is not compatible with aluminum. Copper “receptors” are fastened to the aluminum conductor. Copper is not compatible with aluminum. Aluminum is the anode. Steel and copper are the cathodes.

The lightning conductor did not conduct as designed. Lightning created an internal shock wave from air or moisture expansion, or both. Lightning temperatures may have caused interior moisture to transition to an expansive state (steam). In turn, over-pressures stressed the blade to subsequent failure. Further research into wind turbine blade interior air/moisture expansion issues is needed.

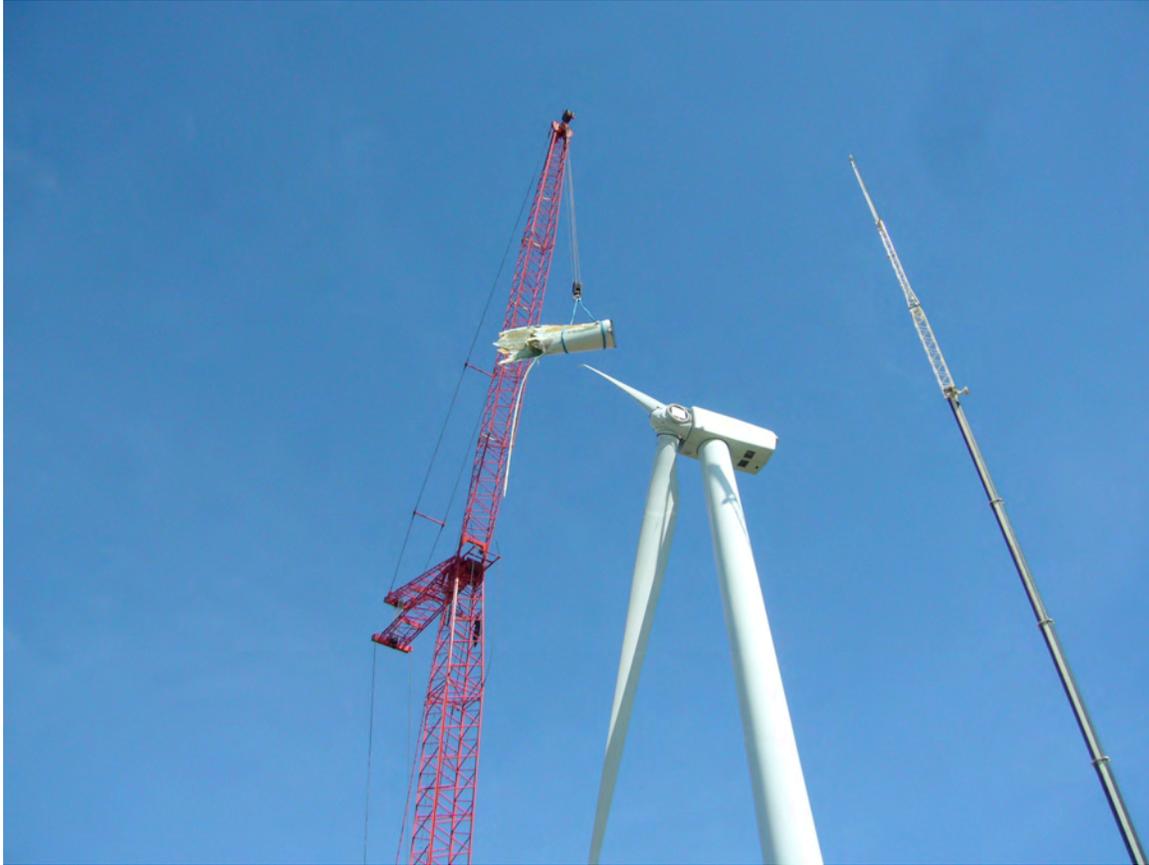
**Figure 3: Removal of damaged blade root by crane**
